# Hythe Town Council

To Hythe Town Council  
Date 29 March 2022  
Status **Non-Exempt**  
Responsible officer Town Clerk and Responsible Financial Officer  
Subject **TARGET HARDENING REPORT F&GP/41/21**

## Open land assets

### Security review 2021

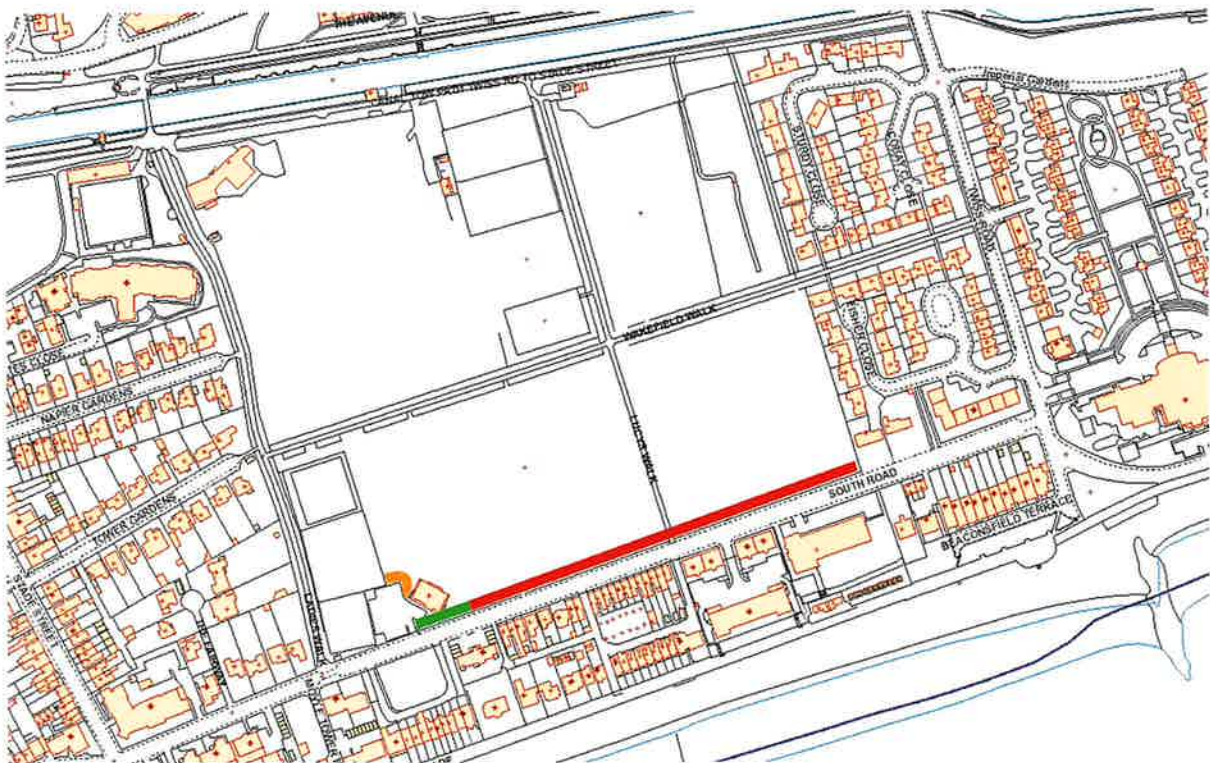
On inspection the remaining southern boundary exposed to road access is protected with a simple wooden post and metal wire arrangement identified red.

There are two vehicular access points, one located at the Eastern end of the site and the other located at the western end.

The access at the eastern point is a wooden field gate secured with an un-shrouded padlock, this point has been identified as red and the access at the western end are timber bollards secured with simple un-shrouded padlocks, this access point has been identified as amber.

**Current estimated penetration time – 1-2 minutes using either vehicle, wire cutters or a socket set.**

Either installing a timber post and metal rail along the entire southern boundary as can be found on Hythe Green, or constructing a low earth bund along this boundary and planting with wildflower s would bring the status of this section of boundary to amber.

Installing both a new barrier and constructing an earth bund would bring this boundary to green.

Either installing a new barrier with a shroud protecting a high security padlock or installing two sentinel posts behind existing barrier would bring the status of this access point to amber.

Installing both a new barrier with a shroud protecting a high security padlock and two sentinel posts behind the new barrier would bring this access point to green.

Installing two sentinel posts behind the existing posts would bring this access point to green.

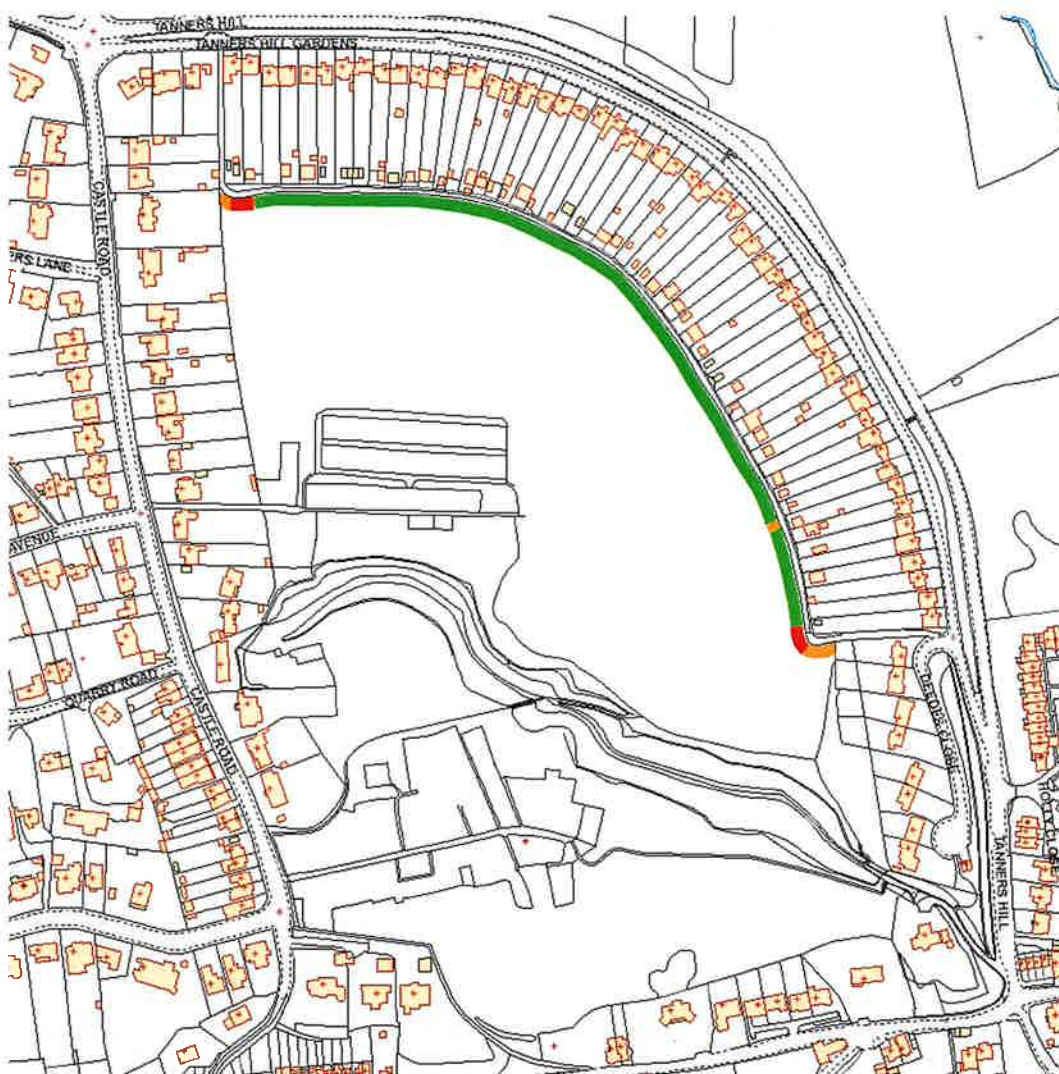
On inspection the remaining boundary exposed to road access has been protected with a very effective ditch and bund arrangement identified as green. At the eastern and western ends of the site there are simple metal post and rail arrangements which have been identified as amber. Finally there is a pedestrian access point in the middle of the site cut through the earth bund that has also been identified as amber.

There are two vehicular access points, one located at the eastern end of the site and one located at the western end of the site. Both are a metal field gate construction secured with a simple un-shrouded padlock and hinges which are not inverted. Both of these access points have been identified as red.

**Current estimated penetration time – 30 seconds using either socket set or spanner.**

Either installing a new barrier with a shroud protecting a high security padlock or installing two sentinel posts behind existing gates would bring the status of these access points to amber.

Installing both a new barrier with a shroud protecting a high security padlock and two sentinel posts behind the new barrier would bring both access points to green.

Extending the earth bund a few meters each side to an opening of 1.5m would bring this access point to green.

Constructing a low earth bund along this boundary and planting with wildflowers would bring the status of this boundary section to green.
